REPORT NO. 95-19

HIGH MOBILITY TRAILER (HMT) TRANSPORTABILITY TESTING

Prepared for:
Commander
U.S. Army Tank-automotive
and Armaments Command
ATTN: AMSTA-TR-E/LTV
Warren, MI 48397-5000

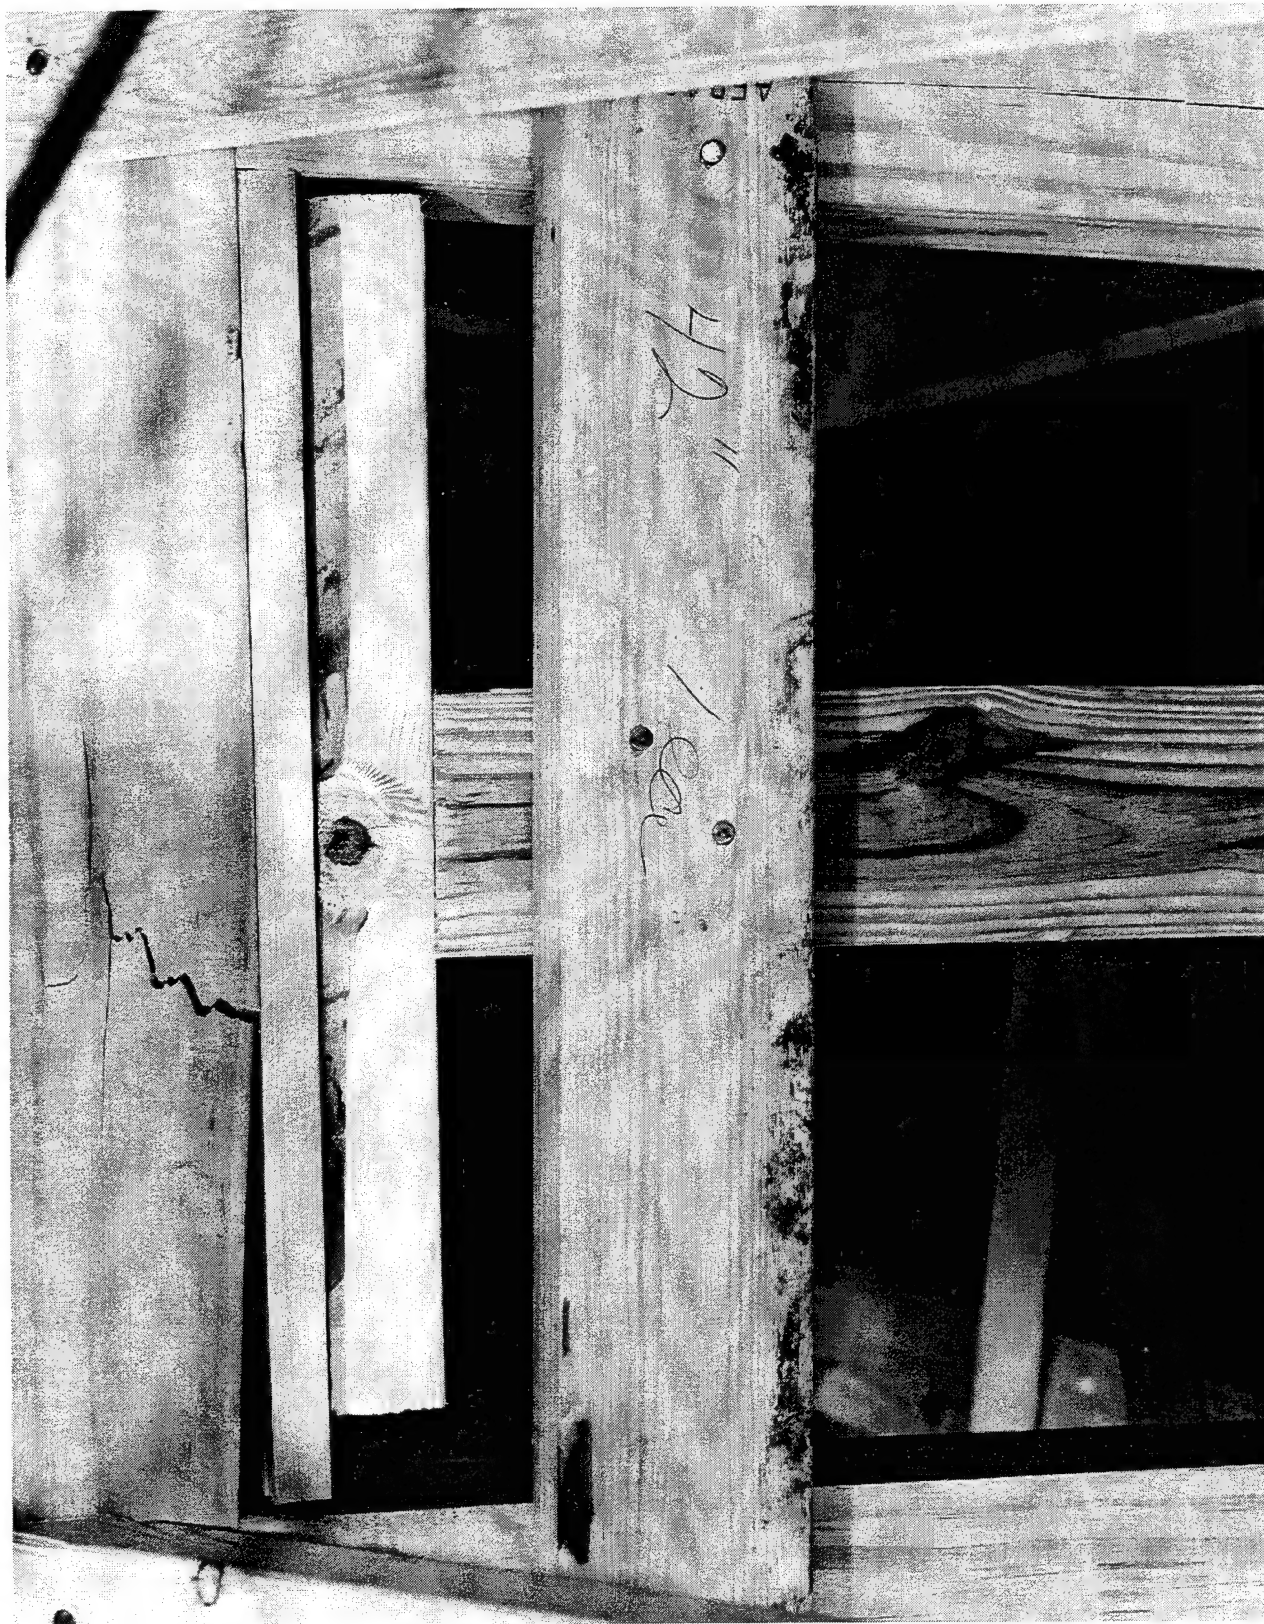
2. Six 3/8-inch steel wire ropes (cables) were used to secure the loaded trailer to the flatcar, one rope/cable through each of the four trailer tiedown anchors and two ropes/cables through the lunette of the tongue. The trailer tongue was placed on a stanchion and the jack was removed. The stanchion cracked while the HMT was being cabled and was reinforced prior to testing (see photo on page 6-3). The aft end of the loaded HMT was forward for rail impact tests at nominal speeds of 4, 6, and 8.1 mph. The front end wall was forward for the reverse 8.1 mph impact.

AO317-SCN96-7-291. This photo shows the crack in the stanchion. The stanchion was reinforced as shown.

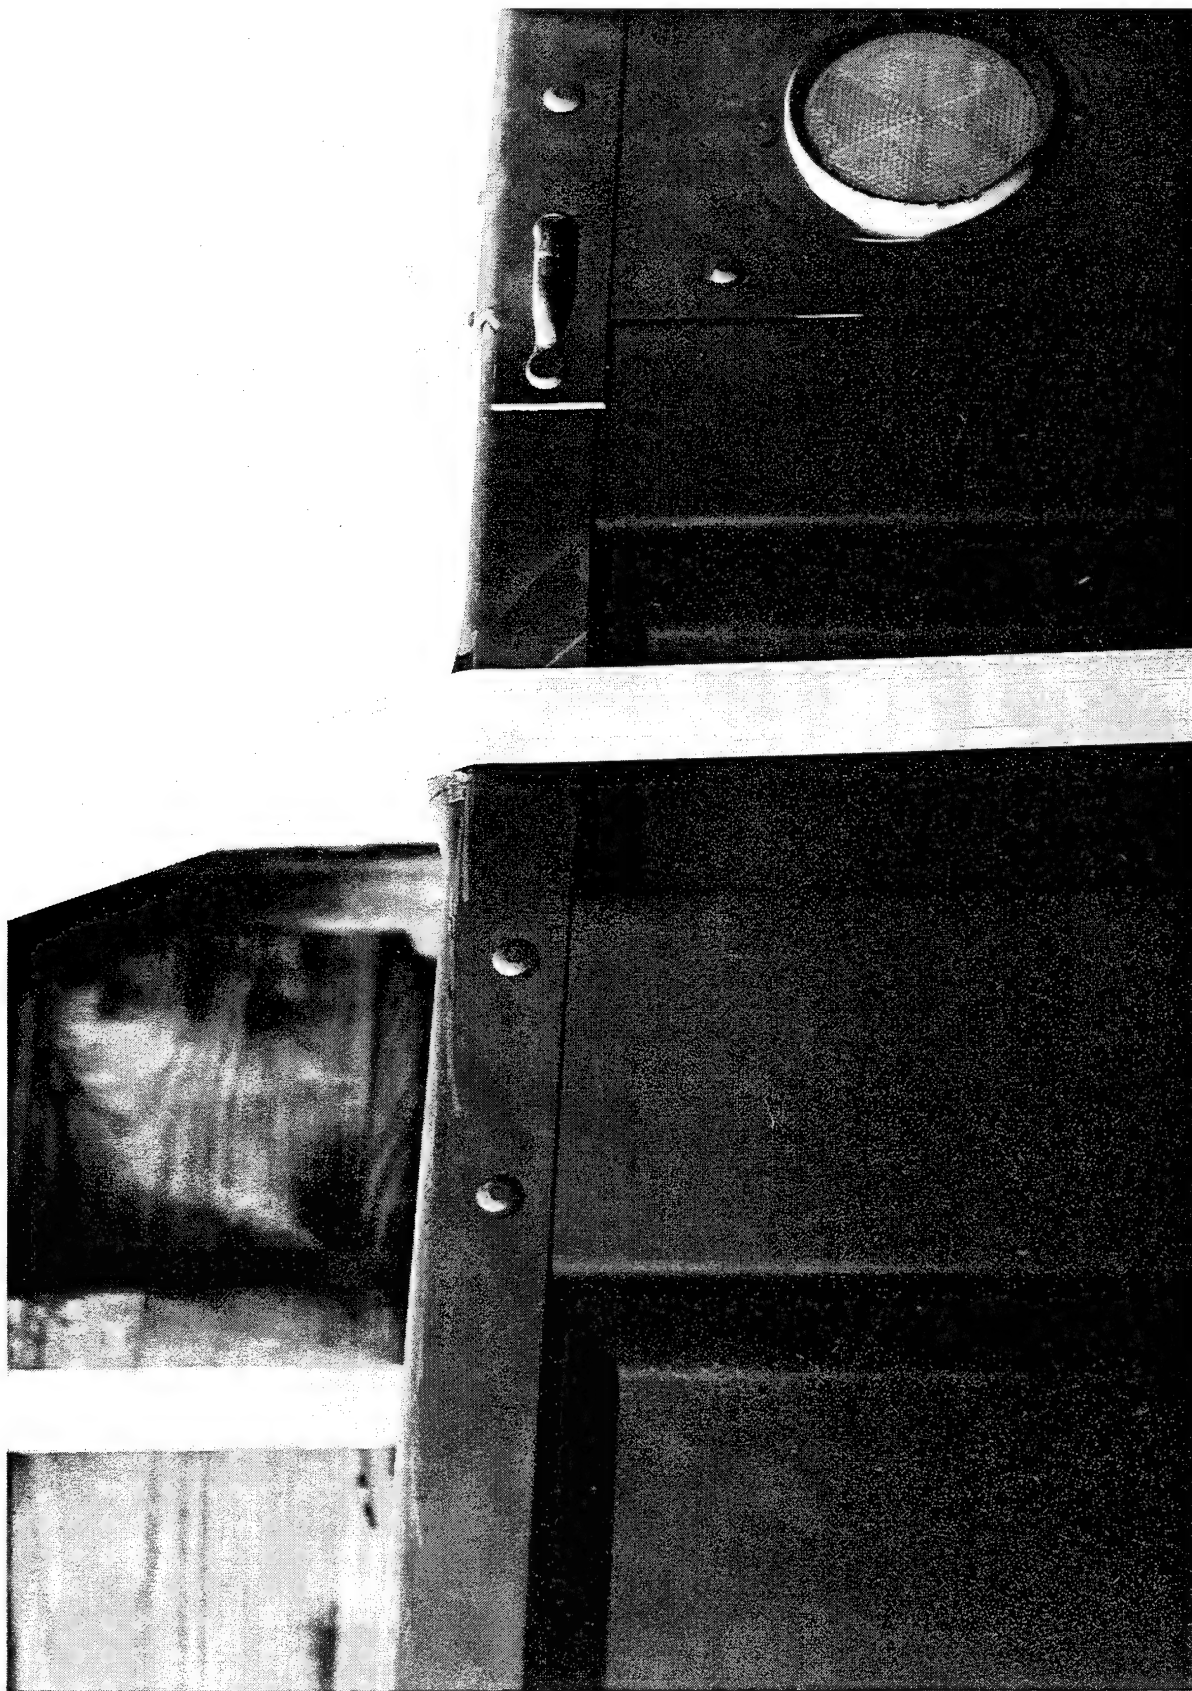
3. The 6 mph impact produced slight deformation in the top lip of the cargo bed sidewall (see photo on page 6-4). The deformation occurred where the steel strap at the front of the HMT crosses the sidewall lip. The 8.1 mph impact increased the deformation in the lip of the cargo

bed sidewall. The strap that extended over the side wall deformation became loose. In addition, the bottom layer of boxes on the pallet was blocked in place and did not move; however, the top five layers moved one inch as a result of the impacts. The 8.1 mph reverse impact caused the strap at the rear of the trailer to break and the front end wall of the trailer to deform outward as much as 1/2-inch. The impact also caused a crack in the front end wall. The crack ran through a rivet hole (see photo on page 6-5).

U.S. ARMY DEFENSE AMMUNITION CENTER AND SCHOOL - SAVANNA, IL	
AO317-SCN96-7-290. This photo shows the load blocked against the forward end wall. Note the indentation in the side wall due to the 1-1/4-inch steel strap encircling the HMT and the pallet unit.

1. The rectangular cross-section of the tiedown anchor creates loading at two points rather than uniform loading on the web strap hooks. To alleviate possible hook damage, the anchor cross-section should be round, rather than rectangular.

3. The arc of the D-ring portion of the tiedown anchor is not conducive for use with 1-1/4-inch steel strapping. The addition of a flat section in the D-ring is recommended to allow the load to be secured by using steel strapping through the tiedown anchor without employing a strap pad.
